Site 60 Stilts Pond

Great Marsh Coastal Wetlands Restoration Plan
Rapid Technical Assessment Site 60

Rapid Field Assessment

Site # 60
Stilts Pond

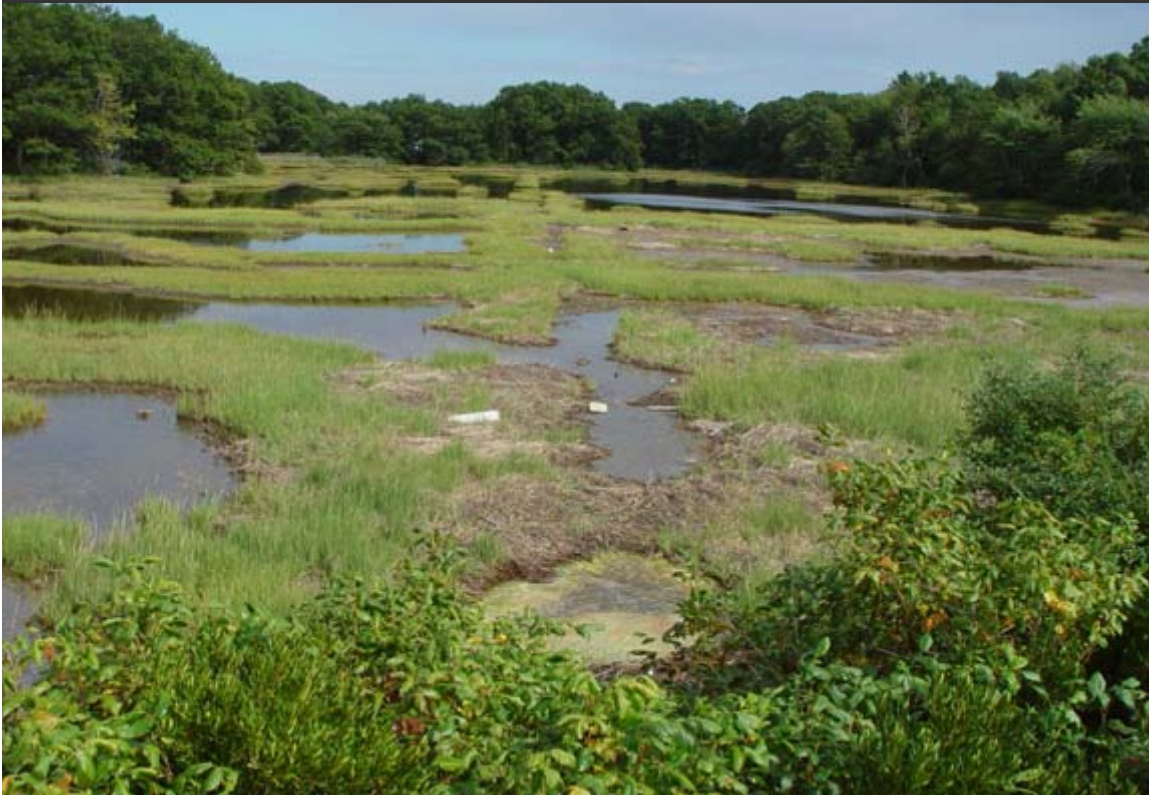
Photo 1 - Overview of Restoration Area Viewing Southeast

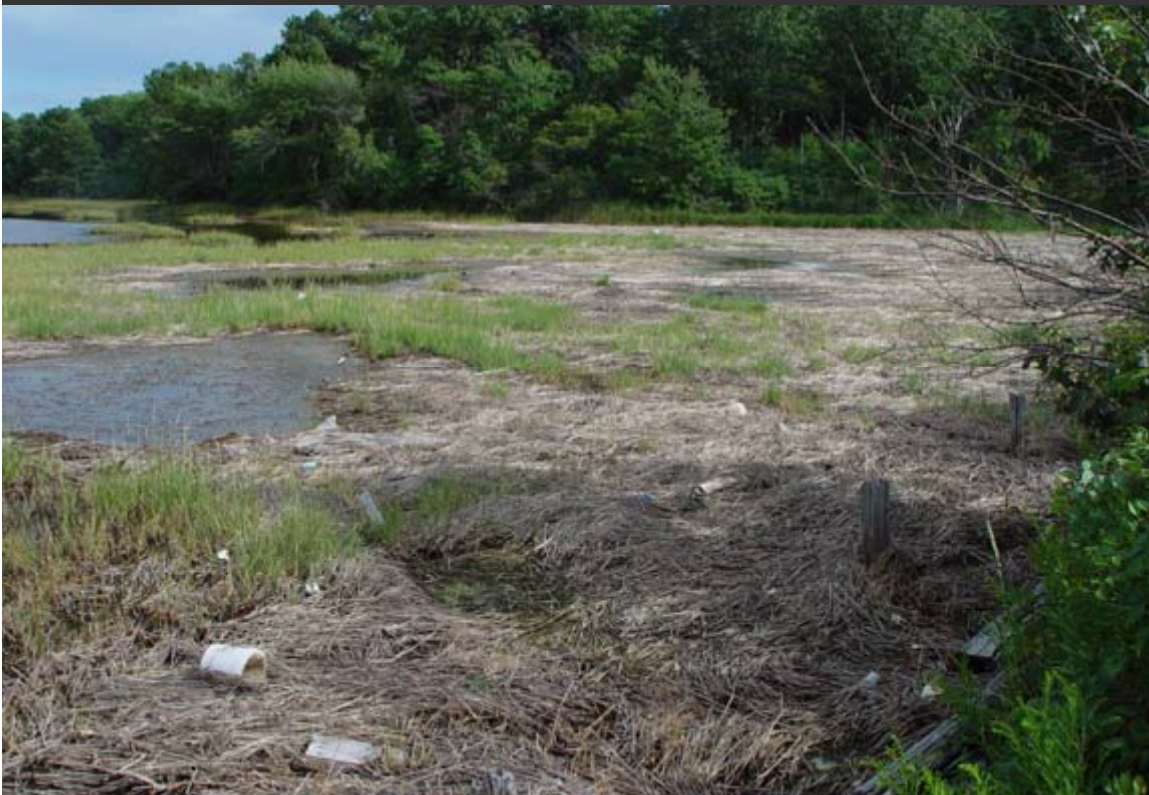
Photo 2 - Accumulated Wrack within Southwestern Corner of Site

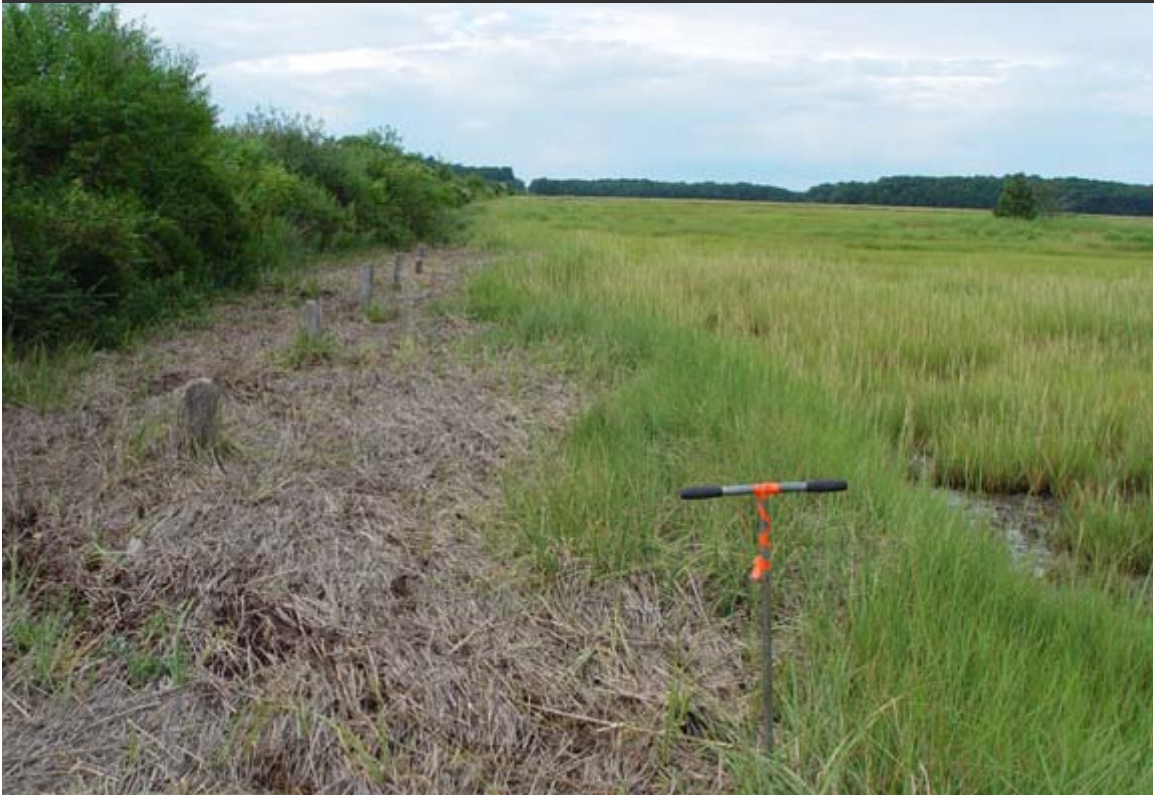
Photo 3 - Location of Former Ditch Flowing North to Parker River

Construction Logistics/Feasibility: The feasibility of restoration actions at the site is enhanced by the level of work necessary to return the site to conditions which existed prior to the impounding of tidal exchange. This action would be limited to the maintenance of approximately 0.5 mi of obstructed ditches. Construction access adjacent to the potential restoration site is difficult; however the area can be accessed off Old Rowley Road to the east. Aside from limited access and the amount of ditch maintenance required, there are no major factors present which would escalate costs over a typical ditching operation. As a result, overall costs for ditch maintenance and additional management elsewhere within the pannes is estimated to be in the range of \$75,000. The level of local support is unknown at this time.

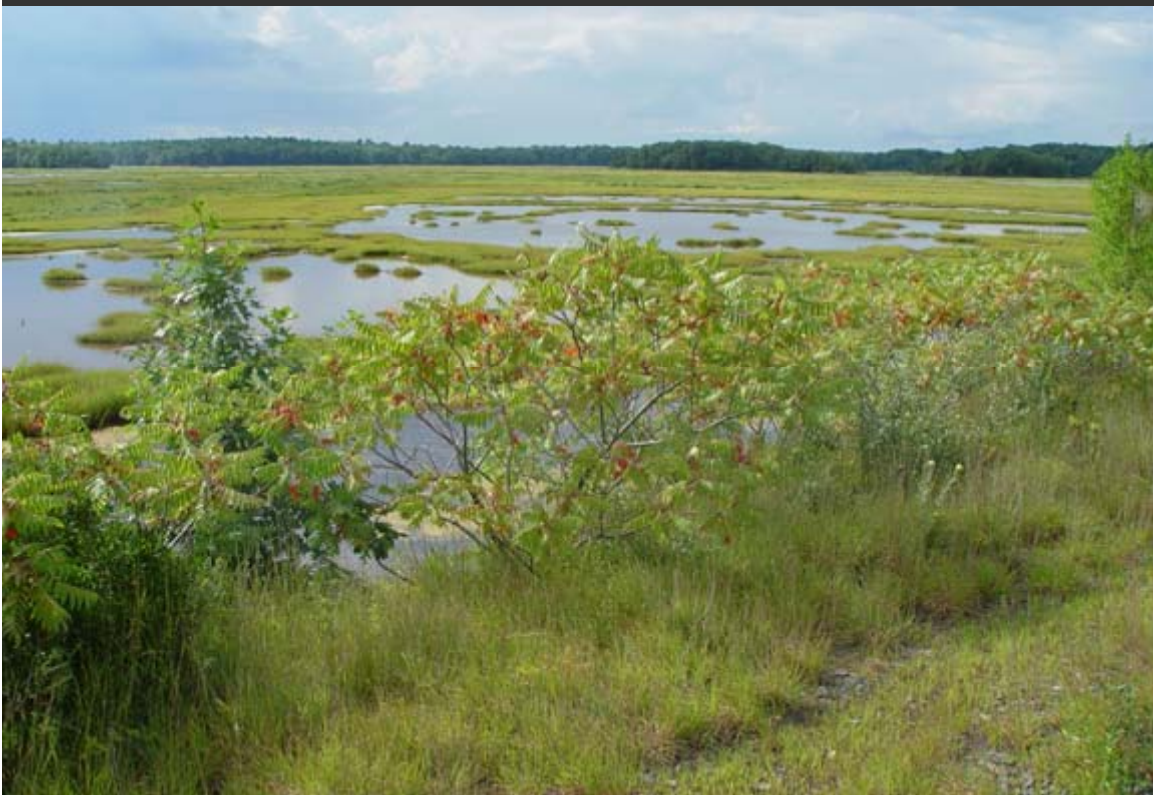
Photo 4 - View of Large Salt Pannes West of Railroad Line

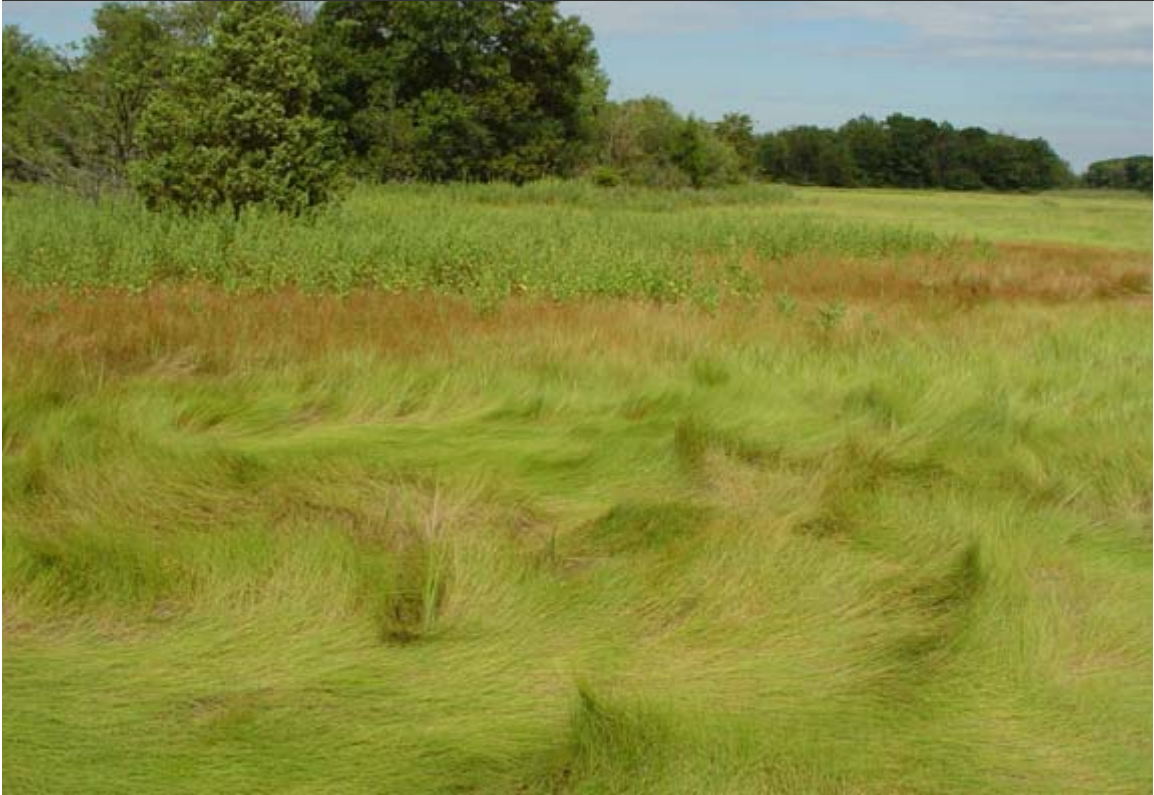
Photo 5 - Healthy High Marsh Downstream of Restoration Area
